## Results From the DCH-1 Experiment

RESULTS FROM THE DCH-1 EXPERIMENT

The DCH-1 (Direct Containment Heating) test was the first experiment performed in the Surtsey Direct Heating Test Facility. It produced experimental data required to understand the phenomena associated with pressurized melt ejection and direct containment heating. The results will be used to develop phenomenological models for containment response codes.

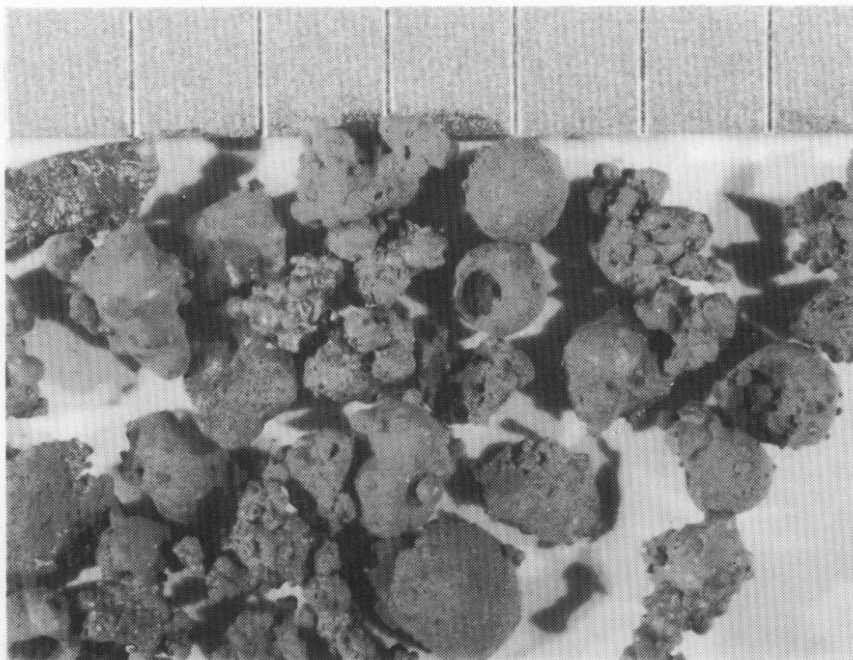
Figure 15. Photographs of Collected Debris from the DCH-1 Experiment (1-mm Scale Marking)

The material recovered from the chamber was studied at high magnification to determine the geometric character of the debris. Photographs of four different size groupings are given in Figure 15 along with a brief qualitative description in Table 8. Some agglomerates were in the sieved samples collected from the chamber so that the estimated mass mean size (DGM = 0.55 mm) may be slightly larger than the airborne material.

The shrink holes seen in the particles were formed during the time the liquid drops cooled in the atmosphere. Heat transfer from the drop in the atmosphere caused a solid outer surface to form. Subsequently, the center of the drop lost heat and a large contraction occurred. The ensuing compressive stress in the outer shell was relieved by the initiation of a fissure. The irregular shapes were attributed to mechanical fracturing by cracking of large solid particles.
